July 28, 2000

The purpose of this letter is to transmit reports completed to date under the Winston-Salem, NC, Liberty Street Corridor Brownfields Demonstration Pilot program. Geoscience & Technology, P.A. (GeoSci) is the environmental consulting firm selected for this program, under the guidance of Mr. Derwick Paige, City of Winston-Salem Department of Enterprise Community Development. Mr. Paige asked that copies of completed reports be submitted to you.

Project: Flowers ESA
Phase I

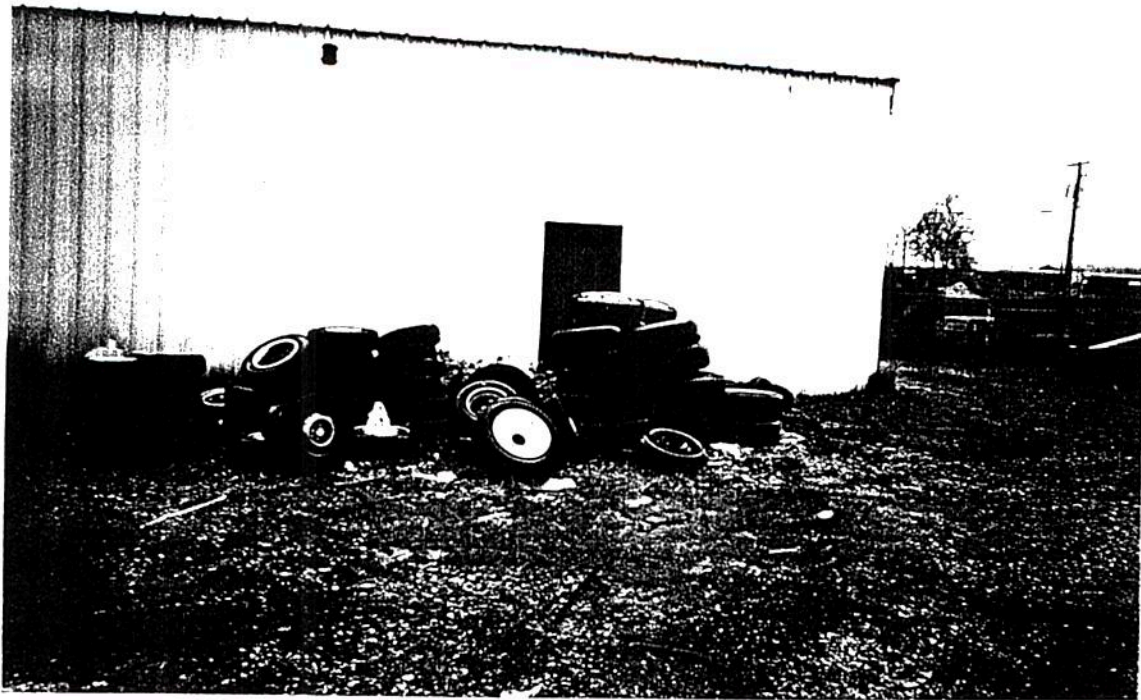
On the date of the site walkover, approximately 3 dozen old tires were observed in various piles throughout the rear portion of the subject site. Used car engine parts, such as transmission appurtenances, were also strewn about the site. Inspection of the interior of the structure revealed spare part storage, primarily an accumulation of used engine parts.

7a: View looking west of used tires stored behind structure.

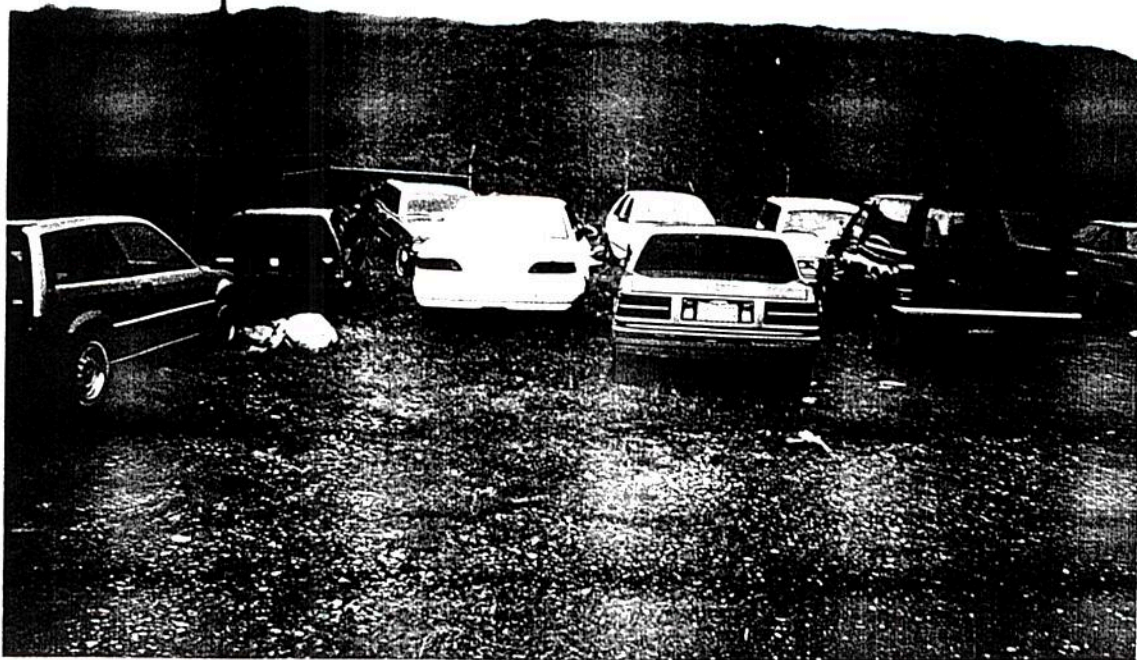
Also noted on the subject property were solid wastes such as paper scraps, bottles and cans, and an air conditioner casing, near the eastern property line. Old cars, possibly used for spare parts, were present throughout the site. These cars number in excess of one dozen.

7b: Spare part/unused vehicles behind structure.

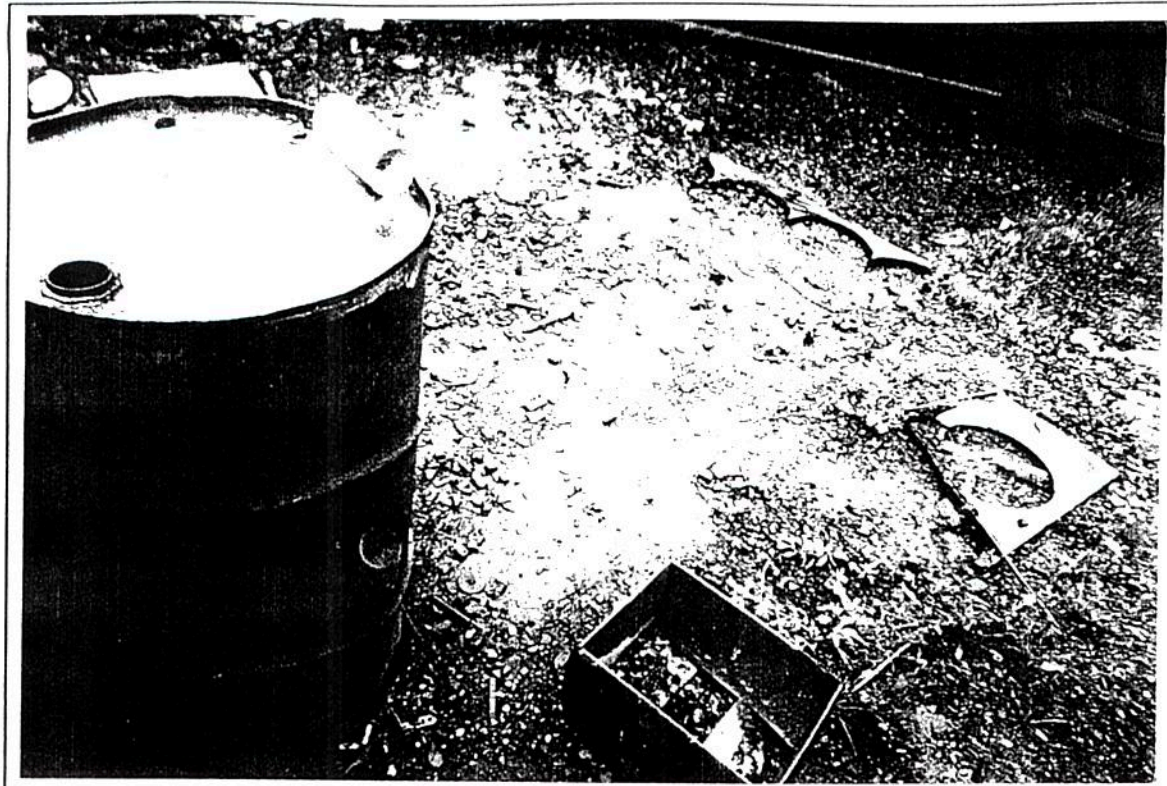
Two 55-gallon drums are present outside (in the rear of) the building as well. One of the drums was approximately one-third full of a viscous hydrocarbon substance, and is partially uncovered. Evidence of soil staining (~8'X6') was evident in this location. The second drum behind the structure was about half full, and was labeled as hydraulic oil. The drum appeared to be devoid of holes, but soil staining was evident at the base of the drum, extending approximately 10 feet downgradient from the drum. Other evidence of staining was found in the southeast corner of the fenced area. A 5' X 5' area devoid of vegetation and dark in color, was observed at the base of a pile of broken up concrete. Dead vegetation extended beneath the fence and toward the stream at the rear of the site.

7c: 55 gallon Drum (1/3 full of oily substance) and associated soil staining.

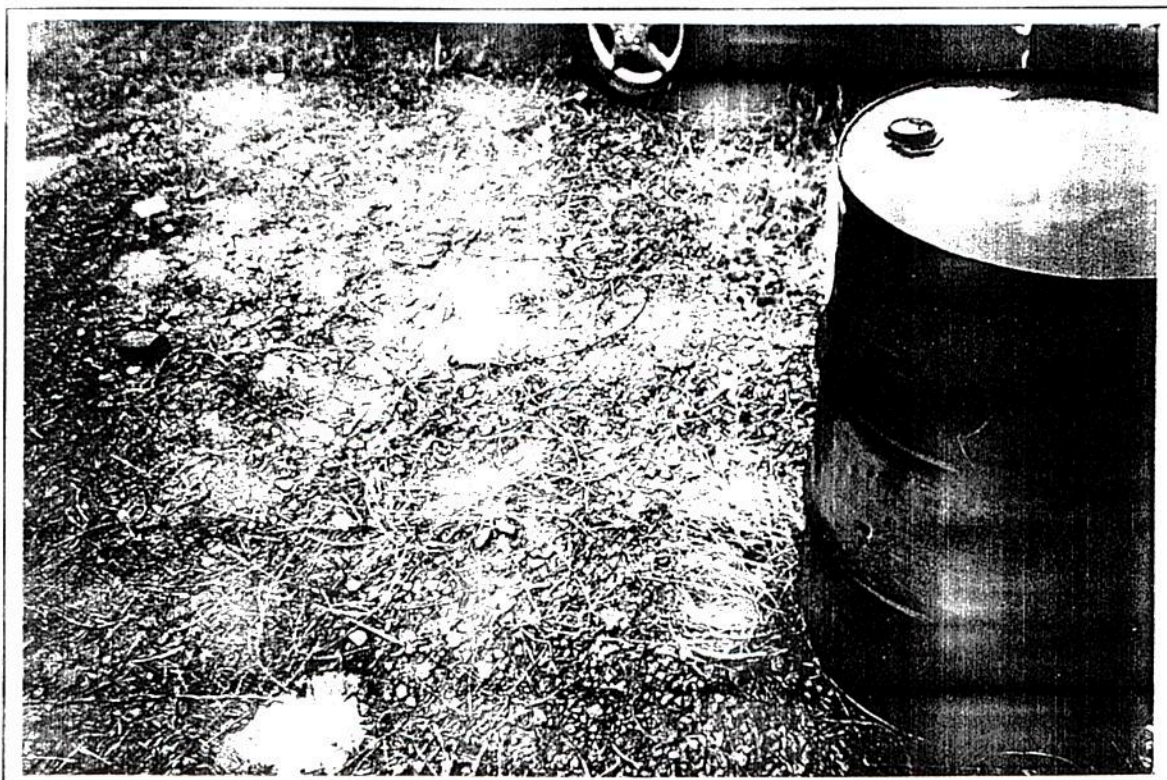
7d: Hydraulic oil drum and associated soil staining.

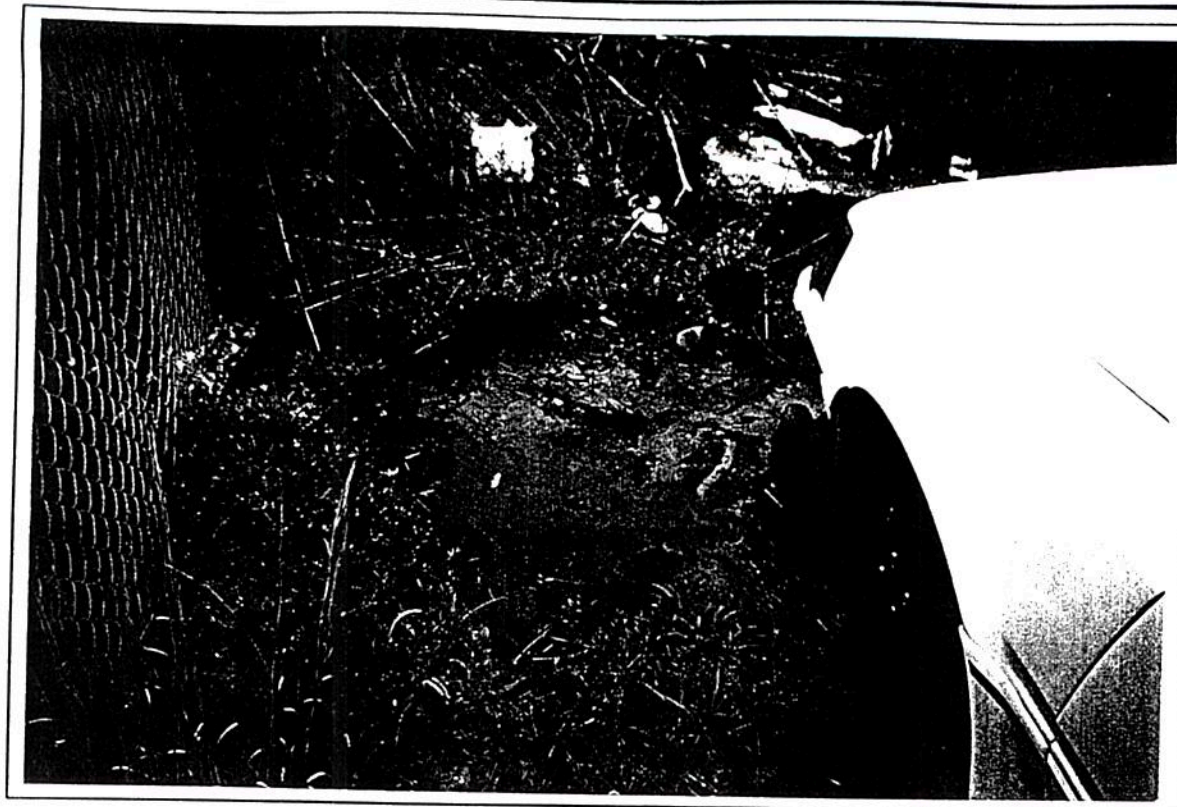
7e: Soil staining in the southwest corner of fenced area.

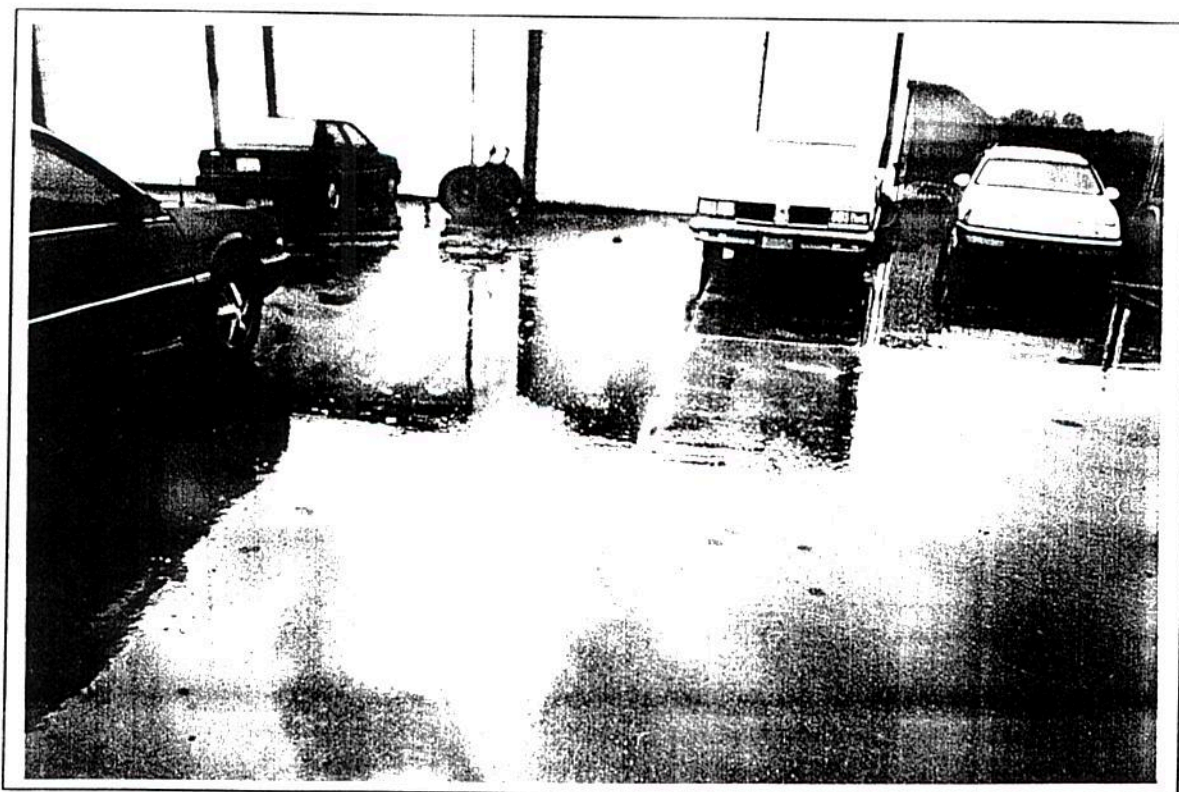
7f: Oil sheen originating from right bay door, and discharging onto Liberty Street.

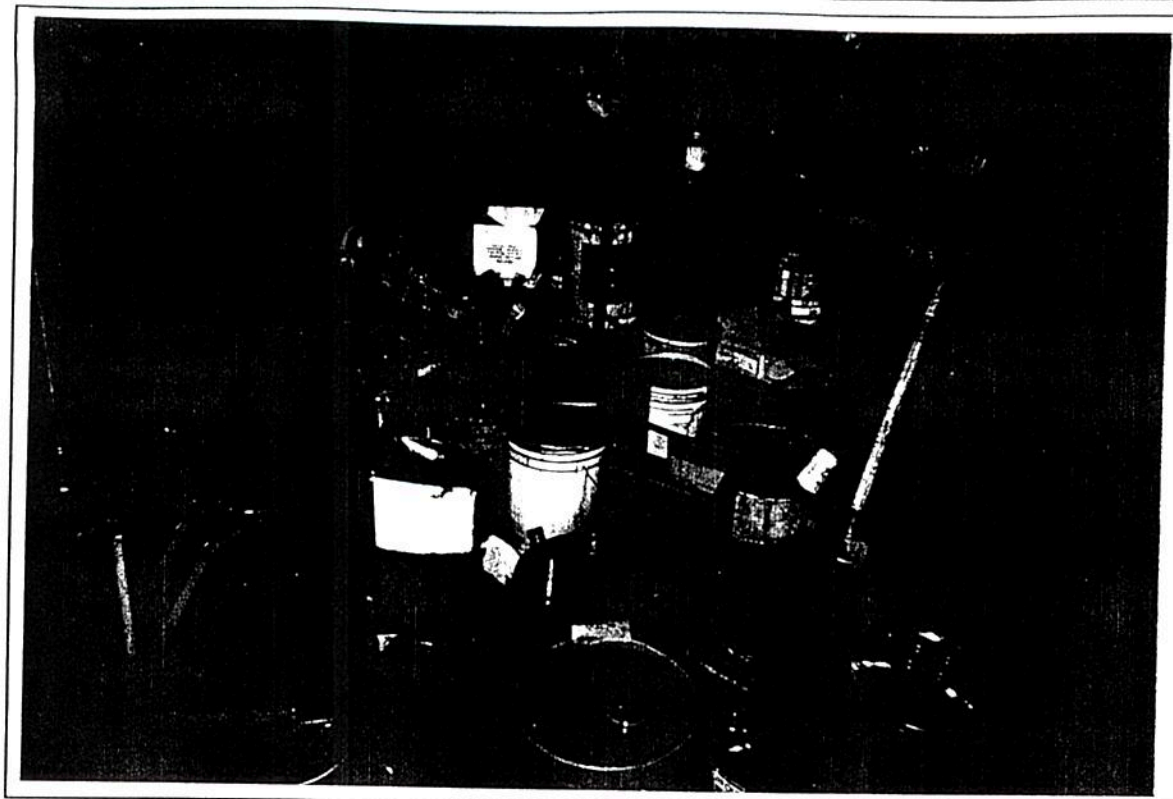
7g: Used oil containers inside structure.

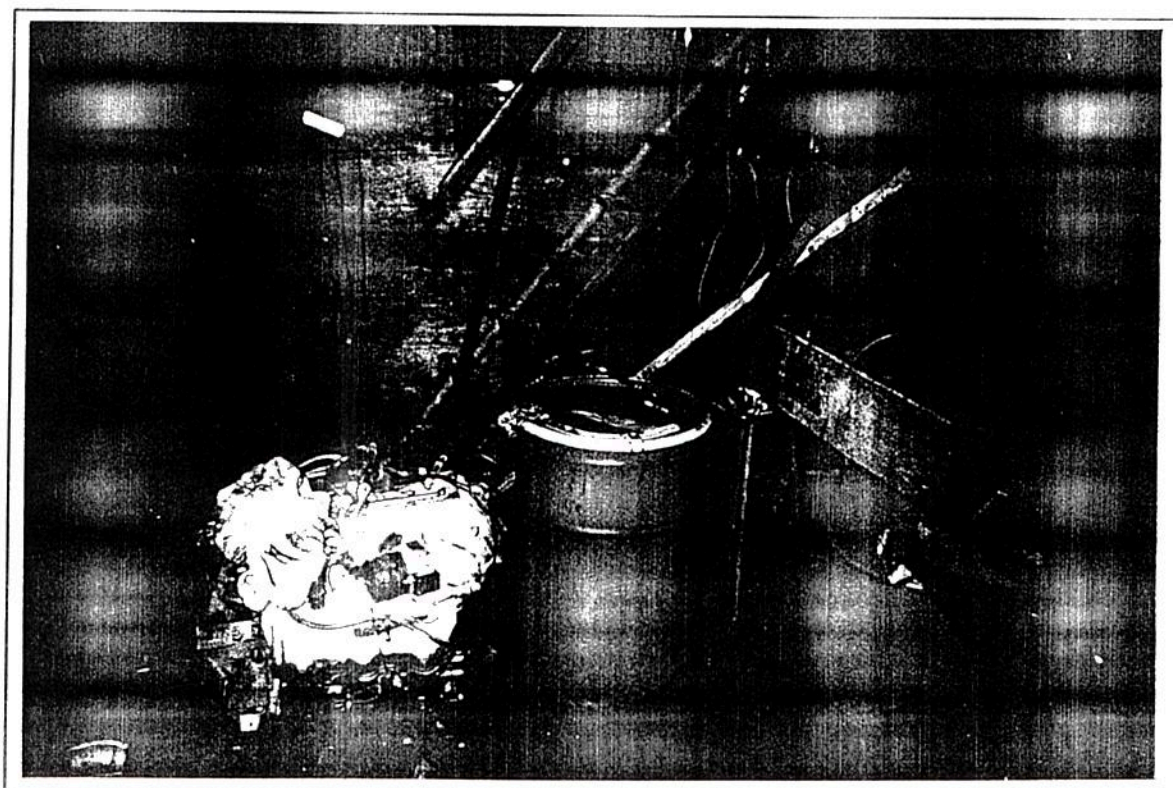
No evidence of commercial or industrial practices was noted on the subject site that would require the handling and/or storage of hazardous waste beyond the use of Safety-Kleen Gold degreaser (Naphtha), and the used oil.

7h: Safety-Kleen Premium Gold Drum.

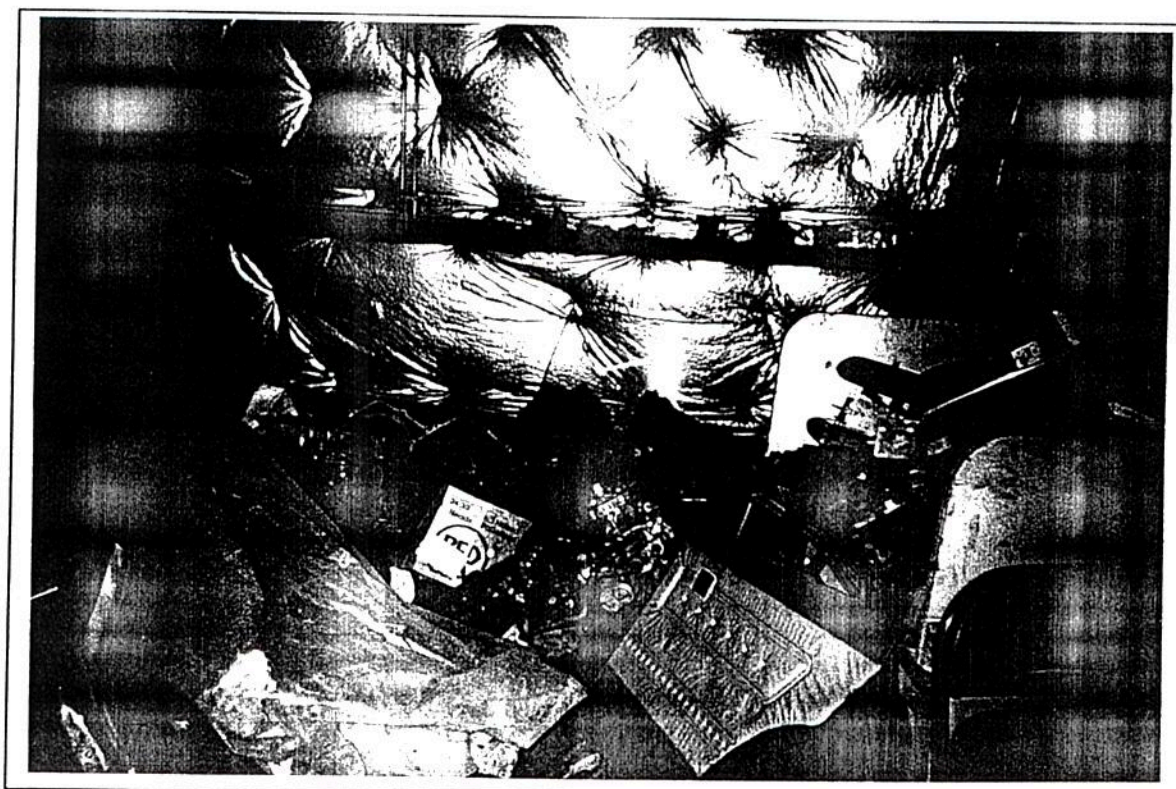
7j: Spare parts room.
